## **DETERIORATION PATTERNS AND MAINTENANCE PRIORITIES OF PAVEMENTS IN NORTHERN BANGLADESH: A PCI-BASED ANALYSIS**

### **ABSTRACT**

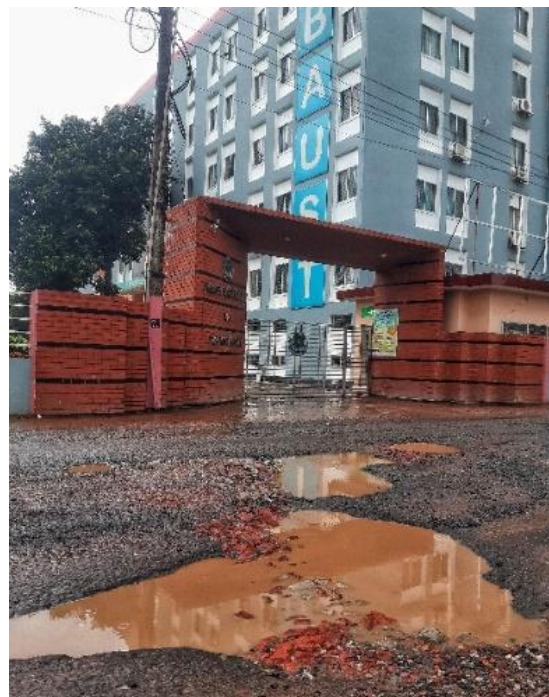
Figure 2: Illustration of a distressed pavement in front of the BAUST Campus

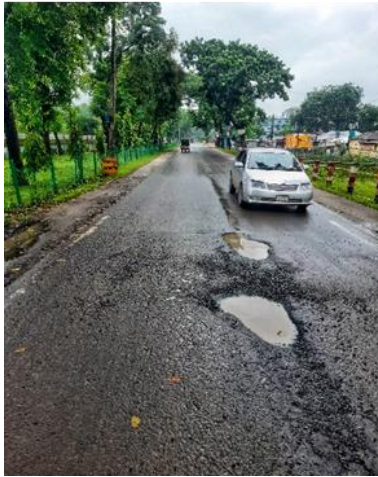
Figure 3: Pothole in the vicinity of a speed breaker

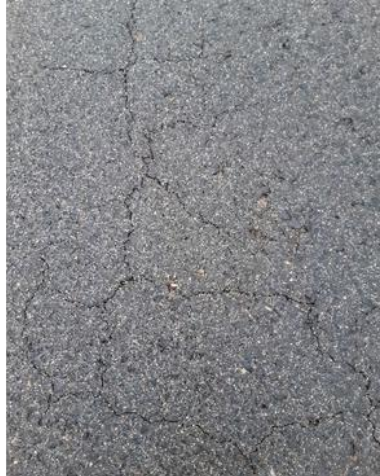
Figure 4: Medium severity alligator cracking

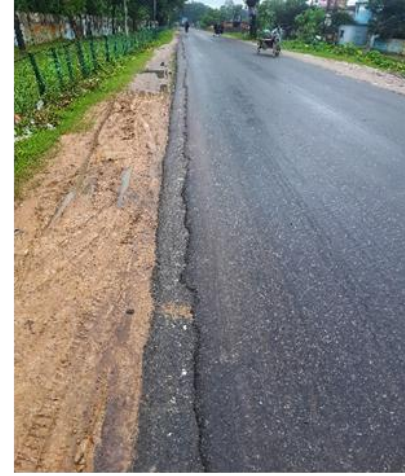
5 occurred likely due to inadequate support at the pavement edges, was recorded along the roadway's periphery. Longitudinal cracks of low severity were also observed as shown in Figure 7. These distresses were classified and analyzed according to the ASTM D 6433-07 standard to assess their impact on the overall pavement condition. The research involved several steps to systematically assess and quantify the pavement's condition, which are detailed below.

Figure 5: High severity edge failure

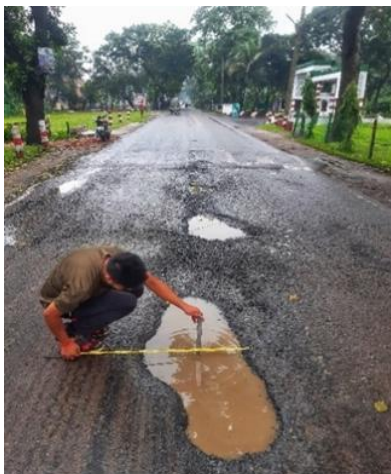
Figure 6: High severity pothole

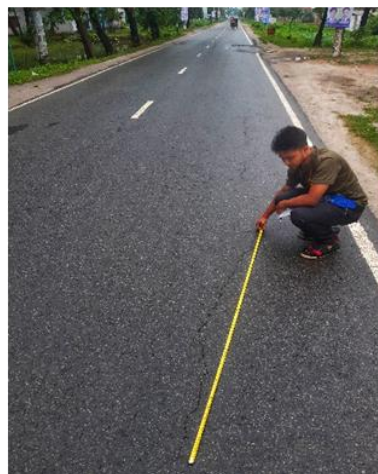
Figure 7: Low severity longitudinal crack

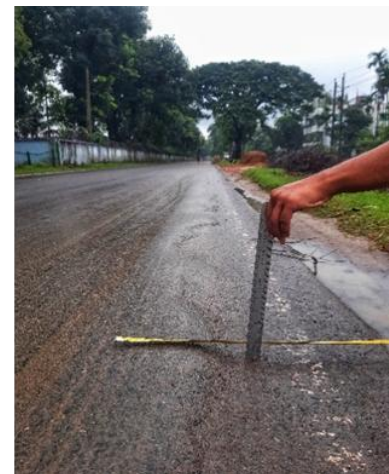
In this research pavement section for Saidpur- Parbatipur Zilla Highway (Z-5011) has been defined and condition survey has been conducted on it. In this study, the visual survey method was employed to assess the condition of the pavement along the 12 km highway block from Parbatipur mor to BAUST Campus. This method involved a systematic visual manual inspection of the pavement surface, conducted by a team of trained surveyors. The team documented visible surface distresses, including cracks, potholes, ruts, and other forms of deterioration. Each distress type was recorded with specific attention to its extent, severity, and location. Distressed areas were physically measured using measuring tapes and rulers, while the lengths and widths of the affected sections were noted for precise quantification. The severity levels of the distress were categorized as low, medium, or high, based on predefined criteria aligned with the ASTM D 6433-07 standard. Photographic evidence was also collected to complement the written records, providing a visual reference for the observed conditions. This comprehensive visual survey approach enabled a thorough assessment of the pavement's current state, facilitating an accurate calculation of the Pavement Condition Index. During the visual survey, various types of pavement distresses were observed and documented. These included longitudinal and transverse cracking, alligator cracking, potholes, raveling, rutting, and edge cracking. Each distress was characterized based on its visual appearance and measured for extent and severity. Potholes, which pose significant safety risks, were identified and measured for their size and depth similar to Figure 3 and Figure 6. Longitudinal and transverse cracking was noted along the pavement lanes, indicating potential issues with pavement structure and environmental factors. Alligator cracking, indicative of structural failure, was observed in several locations as shown in Figure 4. Raveling, characterized by the loss of surface material, and rutting, indicative of deformation under traffic loads, were also documented like Figure 8. Edge cracking similar to Figure

Figure 8: Medium severity rutting
