## **STRUCTURAL PERFORMANCE OF REINFORCED CONCRETE BEAM-COLUMN JOINT RETROFITTED WITH CARBON FIBER REINFORCED POLYMER**

This study investigates the seismic retrofitting of damaged reinforced concrete beam-column joint using Carbon Fiber Reinforced Polymer (CFRP) sheets. A joint was cast with a concrete mix containing 15 mm long 0.25% Galvanized Iron (GI) fibers by volume to improve tensile strength and crack resistance. The joint was damaged under simulated seismic activity and later retrofitted with 200 gsm unidirectional CFRP sheets at the joint region to assess the effectiveness of CFRP retrofitting under reversed cyclic loading conditions. The specimen was tested up to a maximum drift ratio of 8%, evaluating load capacity, ductility, energy dissipation, and crack propagation. The retrofitted joint showed significant strength and stiffness recovery compared to their pre-retrofitted damaged state. The CFRP wrapping enhanced confinement, reduced crack widths, and delayed strength degradation. GI fibers improved damage tolerance, while the CFRP sheets restored and enhanced the joint's seismic behavior, making this retrofitting strategy effective for seismic rehabilitation. By eval

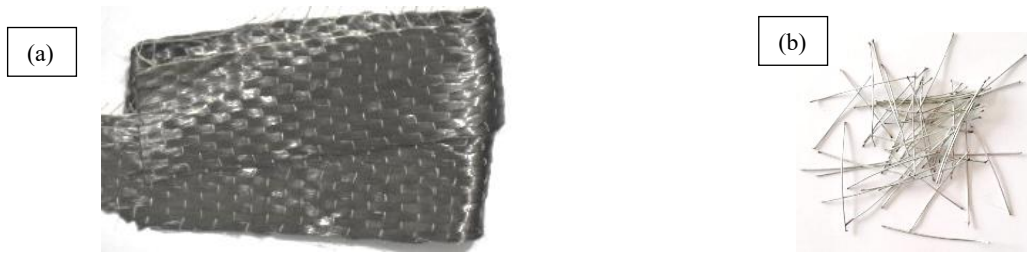
Figure 1: (a) CFRP and (b) GI fiber.

The carbon fiber (Figure 1(a)) was mechanically tested following ASTM D3039, and tensile strength and elastic modulus was 4.05 GPa and 245 Gpa, respectively. Nominal thickness of the dry fabric was found to be 0.26 mm. To enhance the mechanical properties of the concrete, 15 mm long galvanized iron (GI) fibers (Figure1(b)) were incorporated as reinforcement, with a diameter of 0.5 mm and a maximum tensile strength of 370 MPa. GI fibers provides improved post-cracking behavior, ductility, and resistance to impact and fatigue (Ahmed et al. 2024).

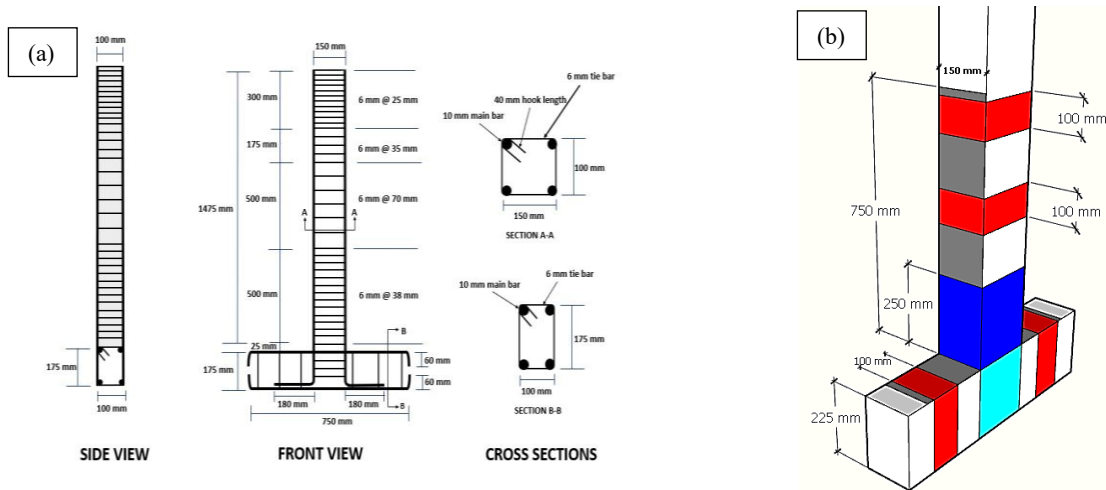
Figure 2: (a) Detailing of Sample, (b) schematic diagram of CFRP.

In this study, a sample with the size of 150 mm×150 mm×1500 mm (Figure 2(a)) is tested. The specimen is made from natural aggregate. Additionally, GI fiber at a level of 0.5% is used. The specimens experienced cyclic loading with a maximum drift of 6% or until failure occurs. A 70 kN axial load is applied continuously to the top end of the column. The damaged zones and cracks are identified and repaired before retrofitting. The CFRP retrofitting process involves applying a single layer of 200 gsm CFRP fabric with overlap according to ACI 440.2R-17 and fully covering the damaged region of the beam-column joint (Figure 2(b)).

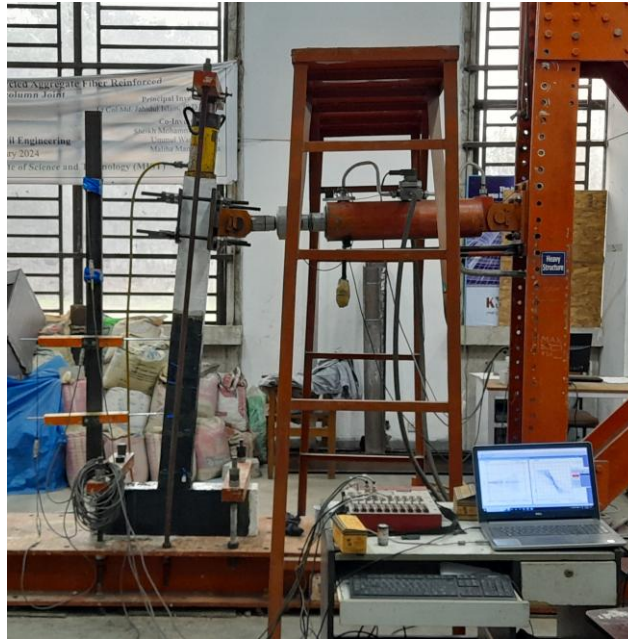
Figure 3: Cyclic loading test setup.

The preparation of concrete beam column joints for carbon fiber wrap application entailed several procedures to repair the beam column joint. First, the whole damaged regions of sample were investigated, and the loose concrete was removed using suitable tools. The damaged concrete was repaired by the application of micro-concrete restoring the vitality and strength to the damaged zones. After the micro-concrete was cured and set, the surface of the repaired places was grinded. After surface preparation, the CFRP wrap was applied. The CFRP was cured following the manufacturer's recommendations for the highest bonding strength. After curing, the retrofitted beam-column joint was tested under cyclic loading to evaluate its performance, as shown in Figure 3. The repair, followed by carbon fiber wrapping technique, improves the structural performance of the sample, and represents a strong solution to better performance under cyclic loading conditions.

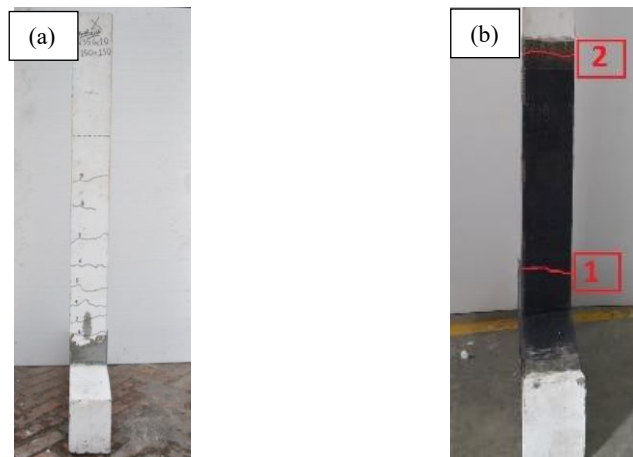
Figure 4: Cracks in: (a) non-retrofitted and (b) retrofitted samples.

In the non-retrofitted beam-column joint, hairline cracks first appeared at service load, with widths of 0.05–0.1 mm. These cracks slowly grew to 0.1–0.2 mm at 1% drift, 0.2–0.3 mm at 1–2% moderate drift, and more than 0.5 mm at 3–4% drift (figure 4). The retrofitted specimen exhibited only two visible cracks, highlighting the improved crack control and enhanced ductility achieved through retrofitting.

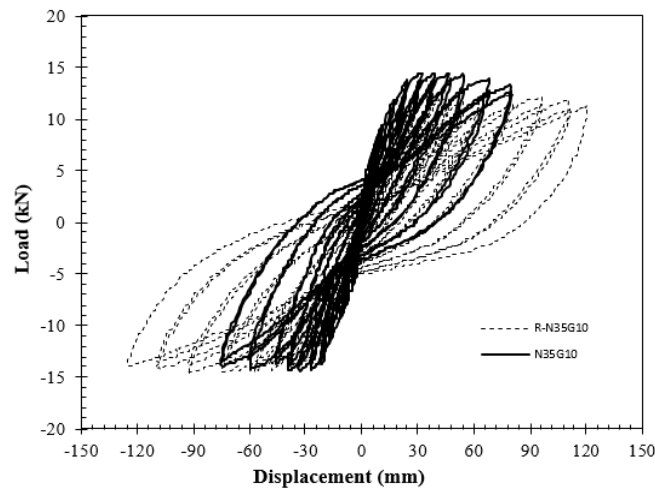
Figure 5: Hysteresis curve.

The variation of hysteretic curves (Figure 5) of R-N35G10 (retrofitted) compared to N35G10 (without retrofitted) refers to the same pattern of ductile material during cyclic loading stage, however with distinct values of maximum load and displacement. The maximum load recorded for the R-N35G10 was 12.3 kN, and the minimum load observed was -14.68 kN. The retrofitted sample had wider load absorbing area, which means that the material could resist more tensile and compressive forces after the retrofit. This retrofitting enhanced its energy dissipation capacity and cyclic behaviour, as indicated by the hysteresis curve coverage. The maximum and minimum load in the normal sample was 13.34 kN and -13.74 kN for the N35G10. As observed in Figure 5, both samples show the same

behavior with regards to the general shape of the curve, which is the usual hysteresis type of response, as the material follows a loading-unloading cycle. By contrast, the retrofitted sample has a 15-20% better performance to resist the extreme load conditions, mainly in compression.

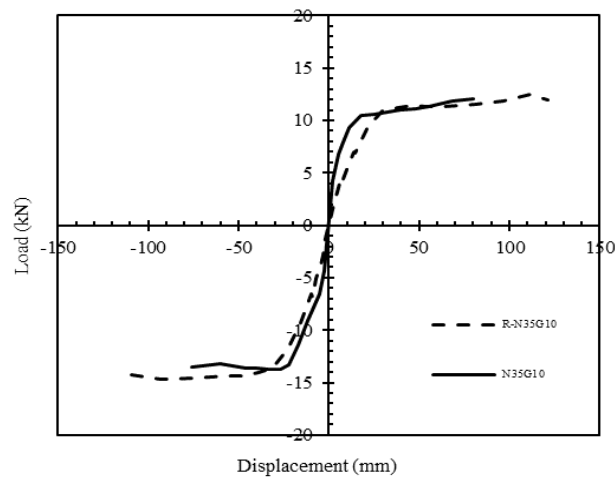
Figure 6: Skeleton curve.

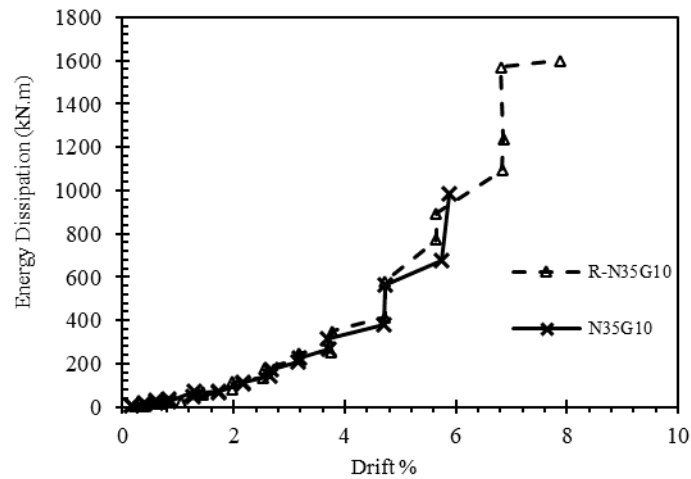
Figure 7: Energy dissipation curve

The R-N35G10 (retrofitted) sample exhibited a significant enhancement in energy dissipation (Figure 7), starting at approximately 200 kN.m at 0% drift and reaching a peak value of 1,600 kN.m at 8% drift. In contrast, the N35G10 (non-retrofitted) sample, while following a similar trend, peaked at 1,400 kN.m at 6% drift. This indicates that retrofitting enhances the sample's capacity to absorb and dissipate energy during seismic loading, particularly at higher drift levels. Both samples began with a stiffness (Figure 8) of approximately 2 kN/mm at 0% drift, gradually reducing to 0.1 kN/mm by 8% drift. However, the R-N35G10 sample maintained slightly higher secant stiffness values at lower drift percentages, indicating that retrofitting provides an improvement in initial stiffness compared to the non-retrofitted sample.

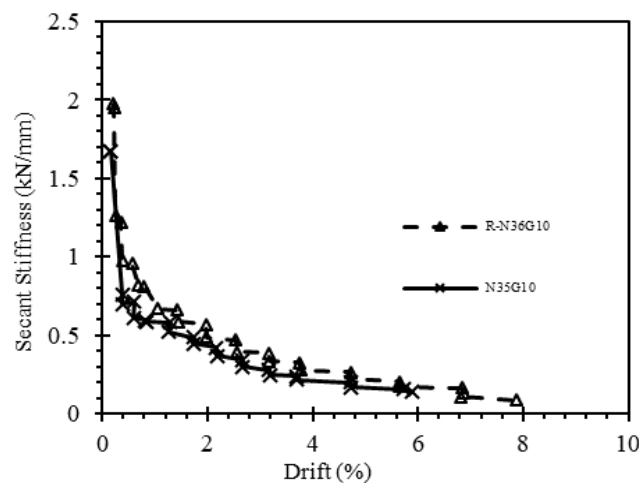
Figure 8: Secant stiffness curve
