## **INVESTIGATION OF REINFORCED CONCRETE BEAM COLUMN JOINTS WITH PLAIN REBAR UNDER CYCLIC LOADING**

### **ABSTRACT**

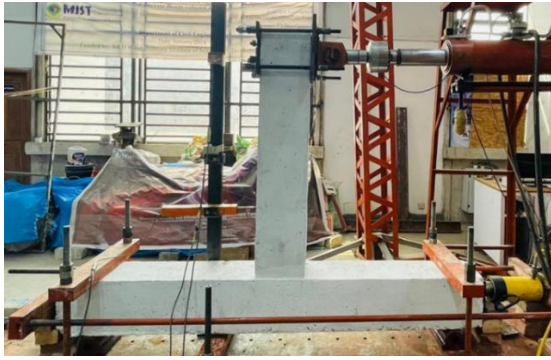
Figure 3: Test setup for the experiment

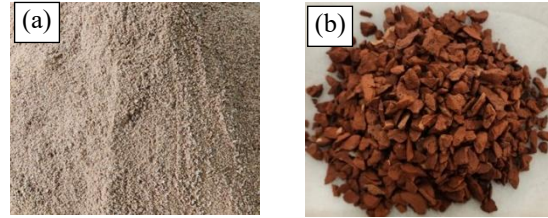
Figure 4: (a) Fine aggregate; (b) Coarse aggregate (locally available brick aggregate).

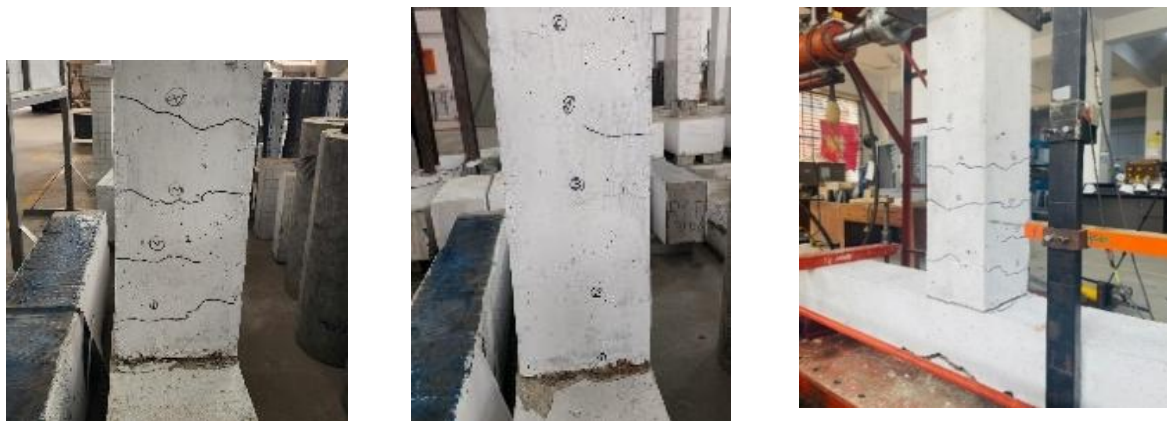
The structural performance of reinforced concrete beam-column joints under seismic loading was gleaned from their failure and cracking behavior (Zhang & Li, 2020), as shown in Figure 5. Due to push-pull loading, tensile cracks were observed on the beam faces perpendicular to the loading direction. The first crack was observed within one-eighth length from the joint. Cracks were then propagated to the other surfaces. Concrete spalling and crushing were observed on the column face opposite to the beam. The lack of yielding in plain bars resulted in buckling failure and an abrupt loss of stiffness following the peak load. These results highlight the need for retrofitting or more ductile alternatives due to the seismic vulnerability of such construction, which is prevalent in older buildings.

Figure 5: Cracks and failure zones of the beam-column joint in different locations.

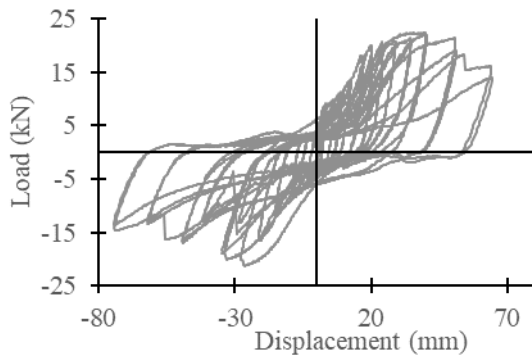
As shown in Figure 6, under cyclic loading the beam-column joint can carry a peak load of  $\pm 22$  kN at  $\pm 40$  mm displacement. The hysteresis loops show that the stiffness and strength decrease, with a 20–25% drop in peak load over twenty-four cycles and a lot of pinching because of bar buckling and bond failure. This means that the material is brittle and does not dissipate energy well. Figure 7 shows a typical nonlinear load-displacement response. It starts with a linear elastic phase and then cracks and yields at a peak load of 22 kN and a displacement of 40 mm. Damage like concrete cracking, crushing, and bar slip causes post-peak softening. The curve shape that isn't symmetrical shows that

the material behavior is non-linear and that the strength changes depending on the direction. The residual strength and displacement before failure show that the joint isn't very ductile and doesn't transfer energy well when it's loaded from the side.

Figure 6: Hysteresis curve (Load-Displacement)

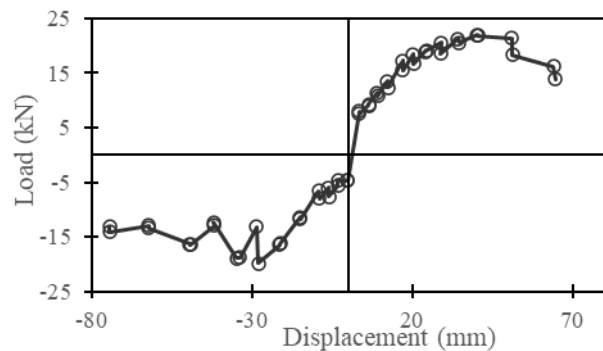
Figure 7: Load-displacement response of the specimen

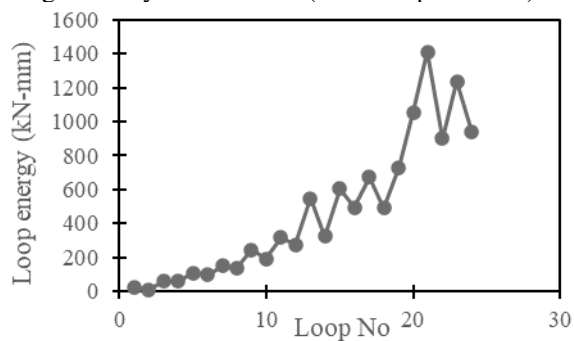
The loop energy went up from about 20 kN-mm at loop one to about 1,430 kN-mm at loop twenty-one as shown in Figure 8. This shows that the behavior changed from elastic to inelastic. The rising trend indicates progressive damage and energy dissipation, while the slight decline after loop twenty-one suggests stiffness degradation or localized failures. The accumulated energy ratio steadily rose from 0% to 100% by loop twenty-four, showing a clear change from elastic response to failure as per Figure 9. The exponential rise in the last loops shows that damage is building up quickly and a lot of inelastic energy is being lost.

Figure 8: Loop Energy vs Loop Number of the Specimen

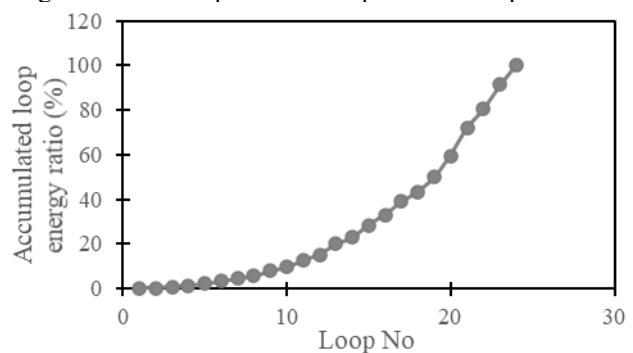
Figure 9: Accumulated Loop Energy Ratio concerning Loop Number
