INTEGRATED ASSESSMENT OF PAVEMENT CONDITION USING VISUAL INSPECTION AND DRAINAGE QUALITY INDEX IN RAJSHAHI CITY

N. Tasnim^{*1}, M. M. Rana² and N. H. M. K. Serker³

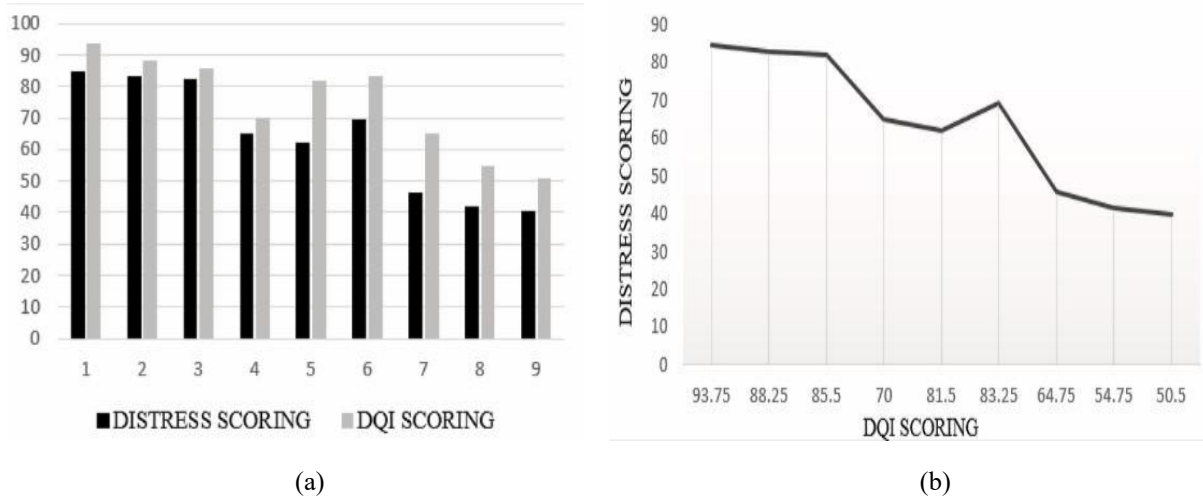
Figure 1. (a)Flow chart on Distress & DQI Scoring and (b) Distress Scoring vs DQI Scoring

Lower DQI Value=Higher Surface Distress; Higher DQI Value=Lower Surface Distress

Roads with low DQI scores consistently show higher pavement distress, highlighting the critical influence of drainage on pavement performance. The graphical data is given in Figure 1.

N603, with high DQI, maintains good pavement condition despite moderate traffic, whereas Z6020 suffers extensive distress due to poor drainage. R681 shows intermediate behavior, where moderate drainage deficiencies align with moderate distress levels.

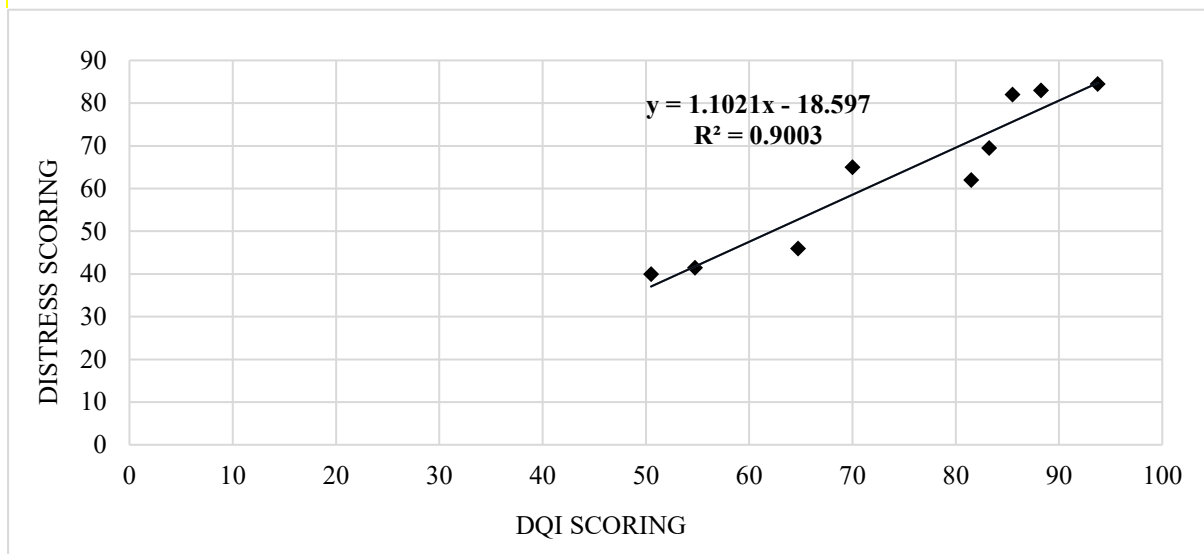
Figure 2. Regression Line for Distress Scoring vs Drainage Quality Index (DQI) Scoring

The graph of surface distress versus DQI, shown in Figure 2, illustrates a clear negative trend between the two variables. The regression line fitted to the data yielded a coefficient of determination (R^2) of 0.9003, indicating that approximately 90% of the variation in surface distress can be explained by DQI. This high R^2 value demonstrates the strong predictive capability of DQI and confirms its reliability as an indicator of pavement condition.

To further examine the relationship between DQI and visual inspection scores, a linear regression analysis was performed, and the results are presented graphically in Figure 2.

The regression analysis indicates a clear and positive agreement between the Drainage Quality Index (DQI) and visual inspection results, highlighting the consistency of the two approaches in assessing pavement condition. This positive relationship demonstrates that visual inspection effectively represents pavement performance trends that are also captured through DQI-based evaluation. The observed agreement supports the reliability of visual inspection as a practical and cost-effective assessment tool, especially for large-scale or preliminary pavement condition surveys.

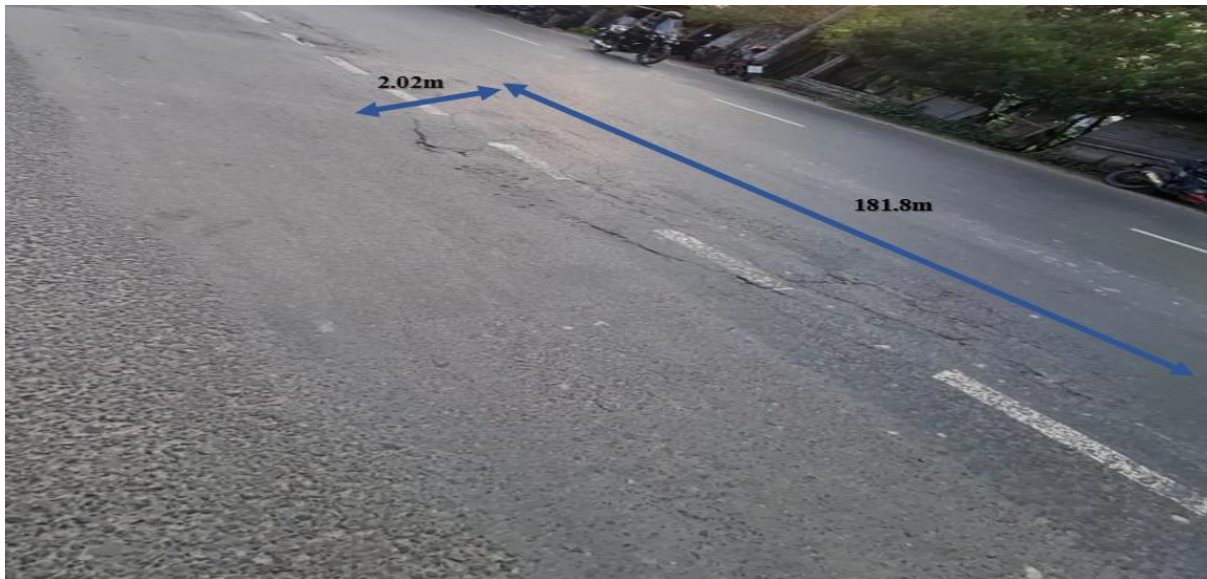
Figure 3. Distress Scoring

Figure 3 and 4 Figure represents the field observations of pavement distresses and the corresponding Drainage Quality Index (DQI) evaluation.

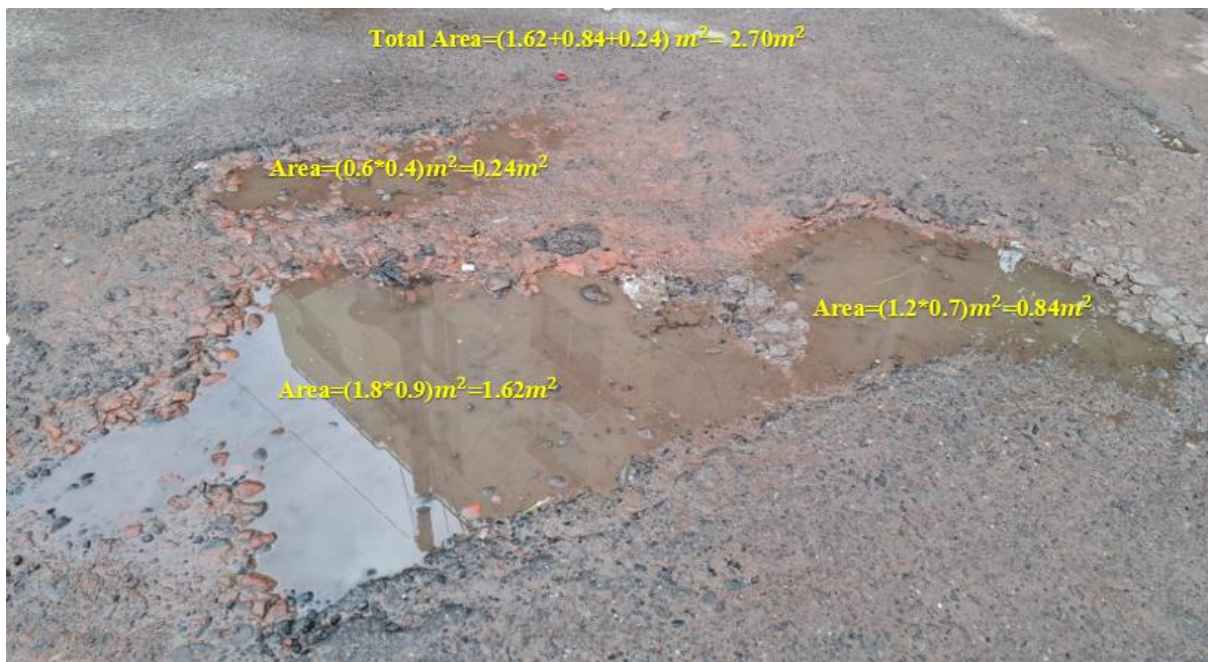
Figure 4. Drainage Quality Index (DQI) Scoring
