EVALUATING PEDESTRIAN SAFETY AND PAVEMENT CONDITIONS IN AN URBAN CONTEXT: A SURVEY-BASED STUDY IN DHAKA, BANGLADESH

In rapidly growing and densely populated cities in developing countries, pedestrian safety and pavement conditions are some of the most important aspects of sustainable urban roadways. In this study, an attempt has been made to carry out a survey-based analysis of pedestrian safety and pavement conditions in several selected roads of Dhaka City, Bangladesh. For an enhanced understanding of pedestrian experiences in dense urban road transport, and to provide practical recommendations, this study will contribute with practical observations. The study used questionnaire surveys and observational assessments. The data were collected from a diverse group of pedestrians to identify major risk factors and defects in pavements. The major focus of the survey was to assess pedestrian perceptions of safety, comfort, etc, on the basis of field observation. For instance, pavement conditions, signage, usability, and maintenance consistency were the main selected parameters which are crucial in terms of urban roadway. Significant levels of pavement defects were evident from the sur

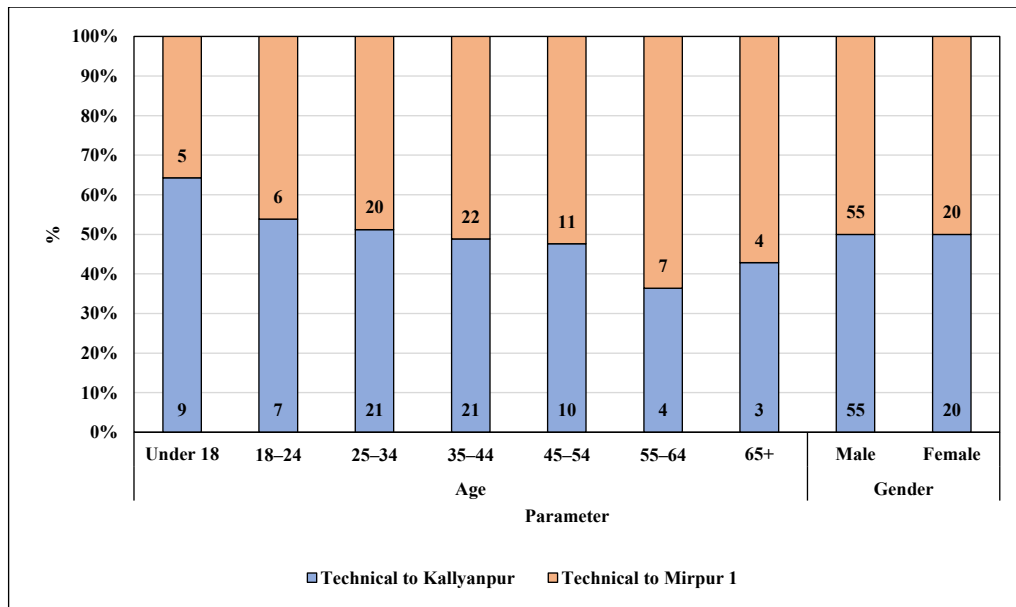
In evaluating the demographic parameter of the pedestrians, it was found that the age distribution was broad. The highest representation was found in the 35-44 (43) age group. In the case of gender distribution, the males (110) significantly outnumbered females (40). Most participants reported walking on the roads daily (60) or weekly (69). Thus, these route users are young and travel by those roads regularly. Among the people surveyed, a total of 100 respondents said that the pavement conditions as "Good," and a total of 36 rated them "Fair" or "Poor,." A large number of people (122) answered that there are cracks or holes in pavements. Additionally, 69 people described the defects as

Figure 4: Survey results of the demographic indicators

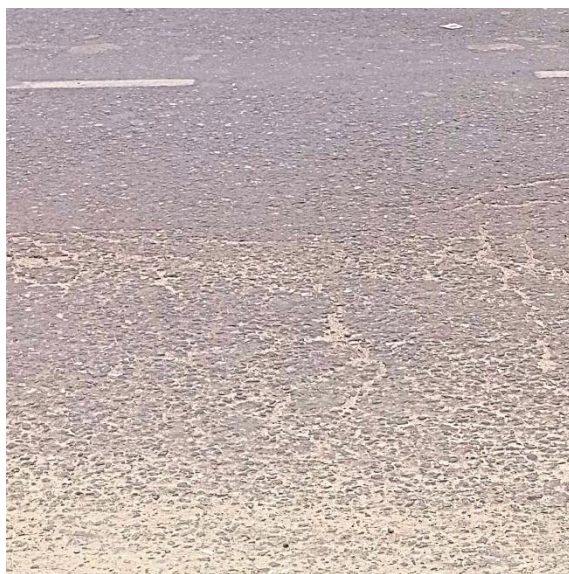
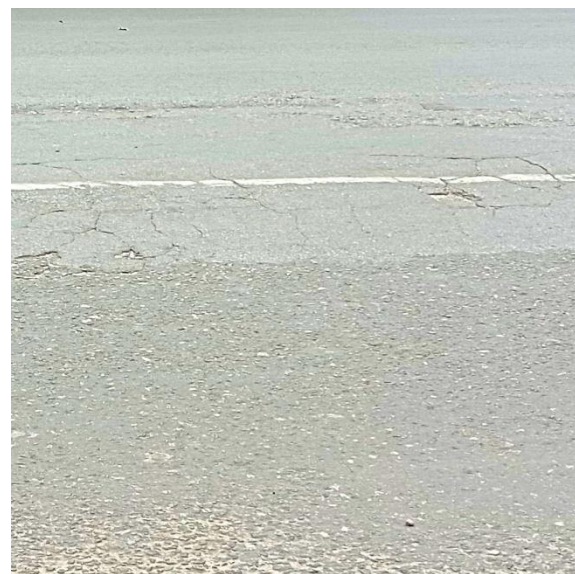
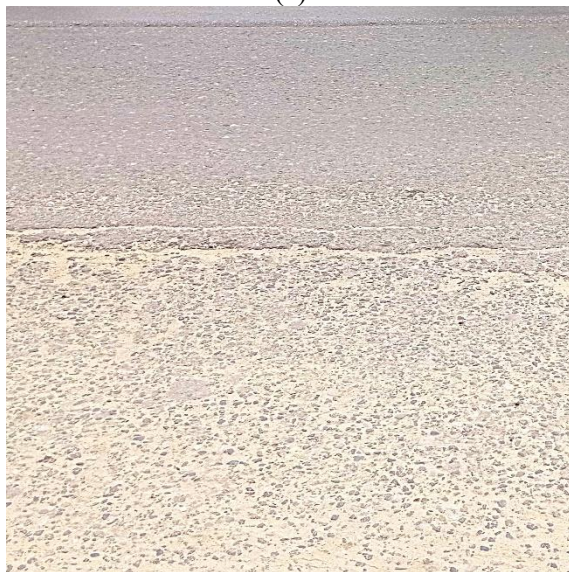
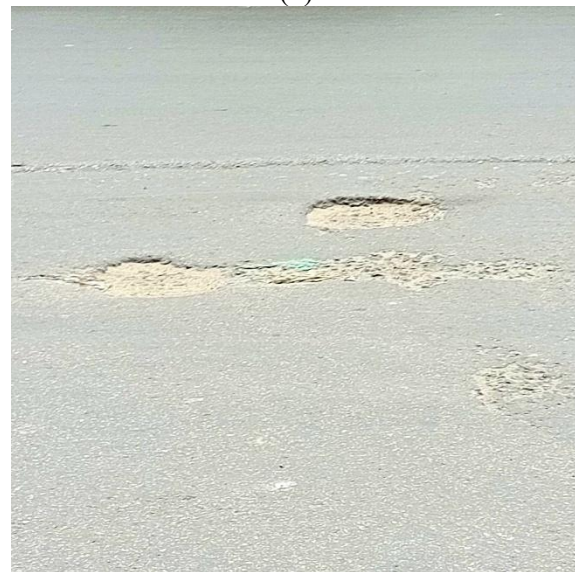
Four main types of pavement defects such as Alligator Cracking, Block Cracking, Longitudinal Cracking, and Potholes, were found from the road condition survey (Figure 6). Potholes were the most prevalent among the defect types. A combined total of 51 instances (30 in Technical to Kallyanpur and 21 in the Technical to Mirpur 1) were observed. Alligator Cracking followed closely. It was observed 44 times in total. Higher concentration was obtained in Technical to Kallyanpur (25) compared to Technical to Mirpur 1 (19). Block Cracking was reported 24 times, again, more frequently in Technical to Kallyanpur (14) than in Technical to Mirpur 1 (10). In every category, the Technical-Kallyanpur route showed a higher count of defects. These results align with respondents' survey feedback. Thus, there is an urgent need for targeted repair and maintenance efforts.

Figure 6: Pavement defects along Technical to Kalyanpur route: (a) Alligator Cracking, (b) Block Cracking, (c) Longitudinal (Linear) Cracking, and (d) Pothole, Pavement defects along Technical to Mirpur 1 route: (e) Alligator Cracking, (f) Block Cracking, (g) Longitudinal (Linear) Cracking, and (h) Pothole, and (i) Condition of pavement defects
